Subject: Trip Report -- On-site Reconnaissance
Bridgeport Name Plate
Monroe, Connecticut
CERCLIS No. CTD011184272
TDD No. 96-02-0006

**EPA-New England REGION 1 SUPERFUND PROGRAM
TRIP REPORT/CHECKLIST**

Site Name: Bridgeport Name Plate

Date of Inspection: 4 April 1996

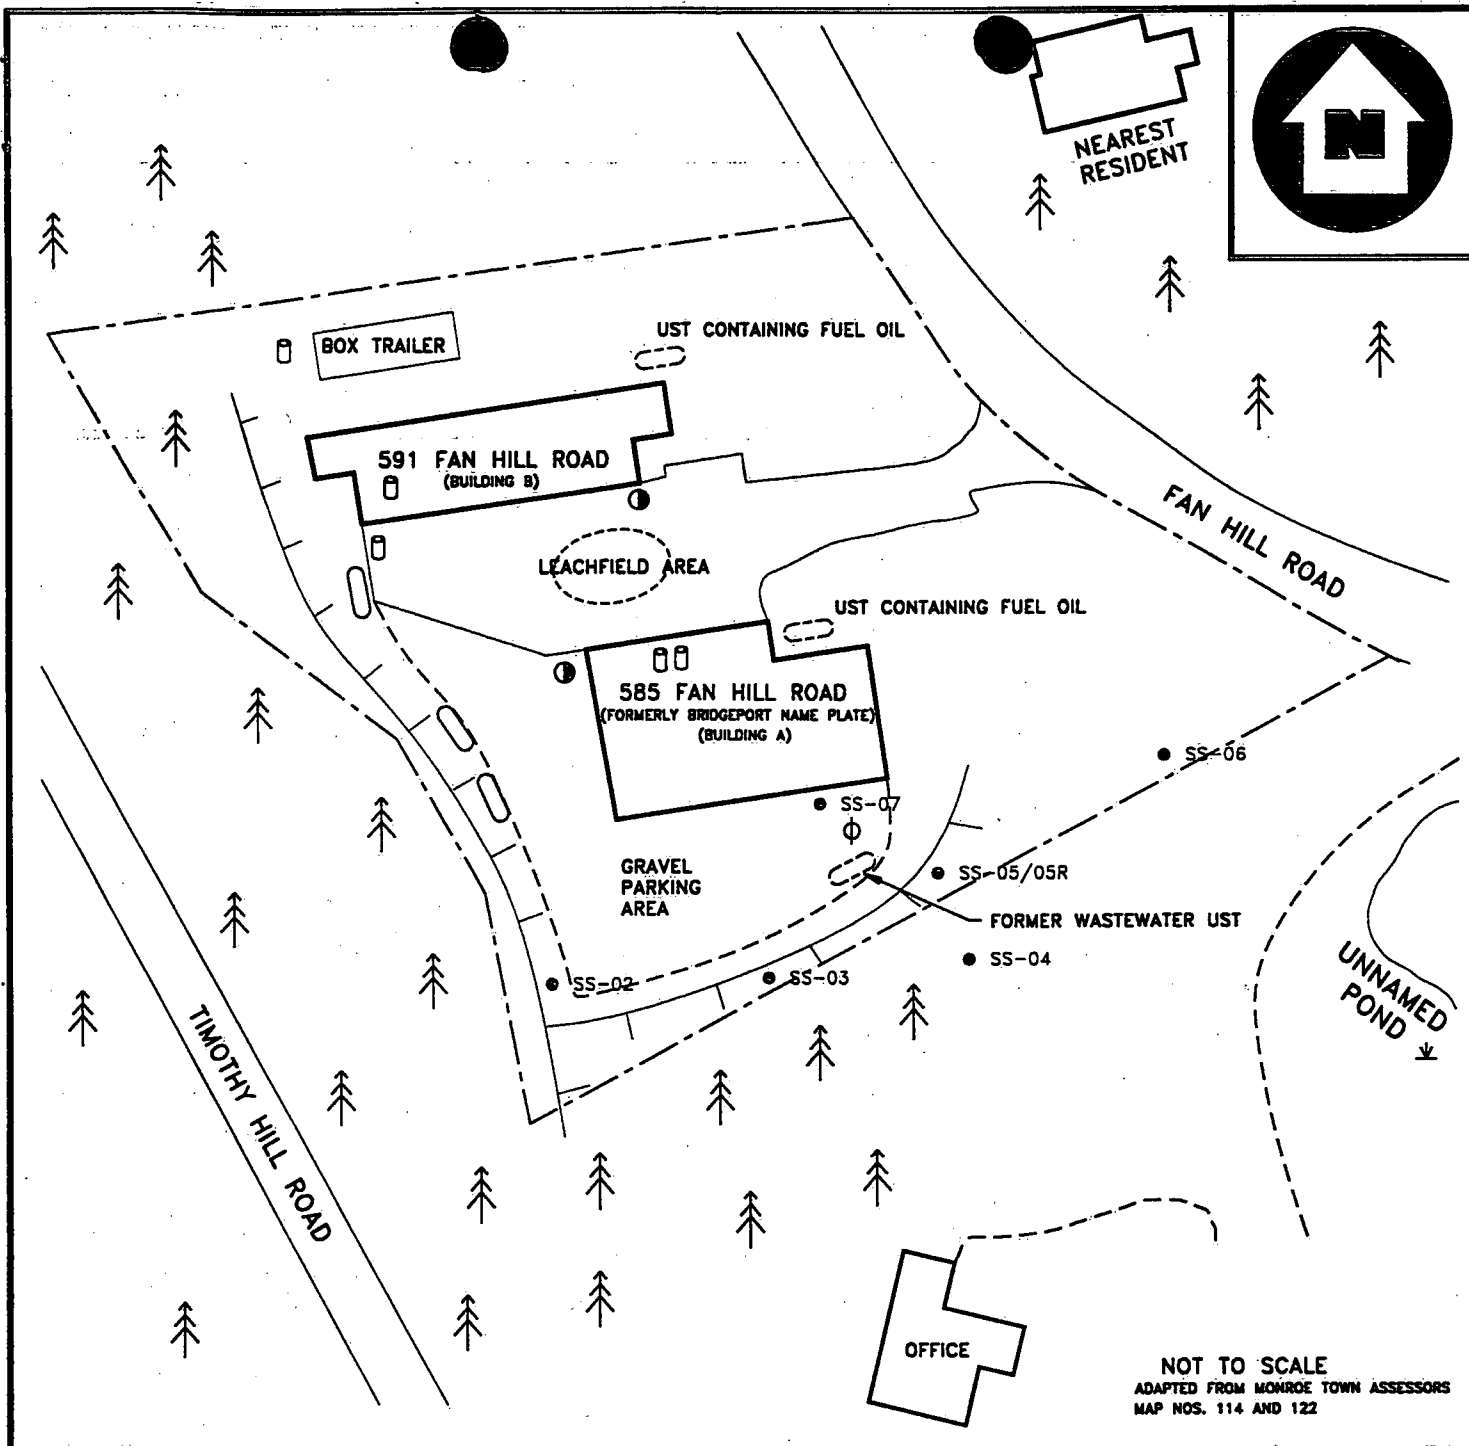
FIGURE 2

(✓) **Drums:** Thirteen unlabeled 55-gallon drums were observed on the property. Three of these drums were located on a concrete floor within 591 Fan Hill Road (Building B) and contained waste oil. Additional drums were located on a concrete floor within 585 Fan Hill Road (Building A) and contained varying amounts of scrap metal coated with cutting oil residue.

The remaining five 55-gallon drums were located outside the buildings on gravel or grass surfaces. One empty 55-gallon drum was located immediately south of Building B. This drum appeared to be identical to the drums located inside Building B, but was empty. Three additional 55-gallon drums were located north of Building B under a box trailer. These drums were empty, rusted, and unlabeled. A 30-gallon drum was also located in this area and was empty, rusted, and unlabeled. One 55-gallon drum was also observed immediately south of

Building A. This 55-gallon drum had an open top, but was empty and rusted.

- ☒ Tanks: ☒ Above-ground: Three above-ground storage tanks (ASTs) were observed along the western property boundary on the gravel section of the parking area. Each AST appeared to be empty, but START personnel were unable to assess residual materials. The AST located nearest to Building A was estimated to have a volume of approximately 250 gallons. The remaining two ASTs were located west of Building B and were estimated to have volumes of 500 and 1,000 gallons. Ms. Marsilio was unable to provide additional information regarding the ASTs.

- ☒ Below ground: Two underground storage tank (UST) fill pipes were observed on the property, each serving one of the two buildings on the property. The first UST fill pipe was located northeast of Building A and the second was located northeast of Building B. One of the fill pipes was imprinted, indicating that the UST was only to be filled with heating oil. START personnel were unable to estimate the size of the USTs. Ms. Marsilio was unable to provide additional information regarding the USTs.

Evidence of a third UST, which reportedly received process wastewater, was observed south of Building A. Two fiberglass fill pipes were observed protruding from the ground in this area. Between the valves, an access hatch was observed to be firmly bolted to the UST. The access hatch was covered with a piece of plywood. An 8-inch fiberglass pipe exited Building A and was observed to extend towards the UST. START personnel were unable to determine the contents of the UST. No signs of soil staining or stressed vegetation were noted around the UST or surrounding area.

☒ Stained Soil: Stained soil was observed in the gravel parking area west of Building A. Two dump trucks owned by J. H. Marsilio were located on the gravel parking area, over the observed stained soil area.

- (✓) Other:** Twelve lead-acid batteries of various sizes were observed on a wooden pallet outside the northeast corner of Building B. The wooden pallet was located on property soils.

An oil pan was observed on the soil near the 250-gallon AST, outside Building B. The oil pan was noted to contain approximately 1 to 2 gallons of waste oil.

An unknown number of 5-gallon containers were located along the western exterior wall of Building B. These 5-gallon containers were partially full of an unknown substance. Several of these 5-gallon containers were open and contained water.
